# STATE OF THE STREAMS

## 2021 WATER QUALITY SYNTHESIS REPORT

MSD, in cooperation with the United States Geological Survey (USGS), operates a Long-Term Monitoring Network (LTMN) to collect physical, chemical and biological data about streams in the Louisville Metro area. This State of the Streams Report is focused on the conditions of fish, aquatic insects, algae, stream habitat, bacteria, nutrients, total suspended solids (sediment in water), copper, dissolved oxygen, and water temperature of the streams in our community, and whether or not these are improving. Data has been collected at 27 Long Term Monitoring Network sites since 1999. This information helps MSD make decisions about where to focus efforts and understand the status of water quality of streams in the region.

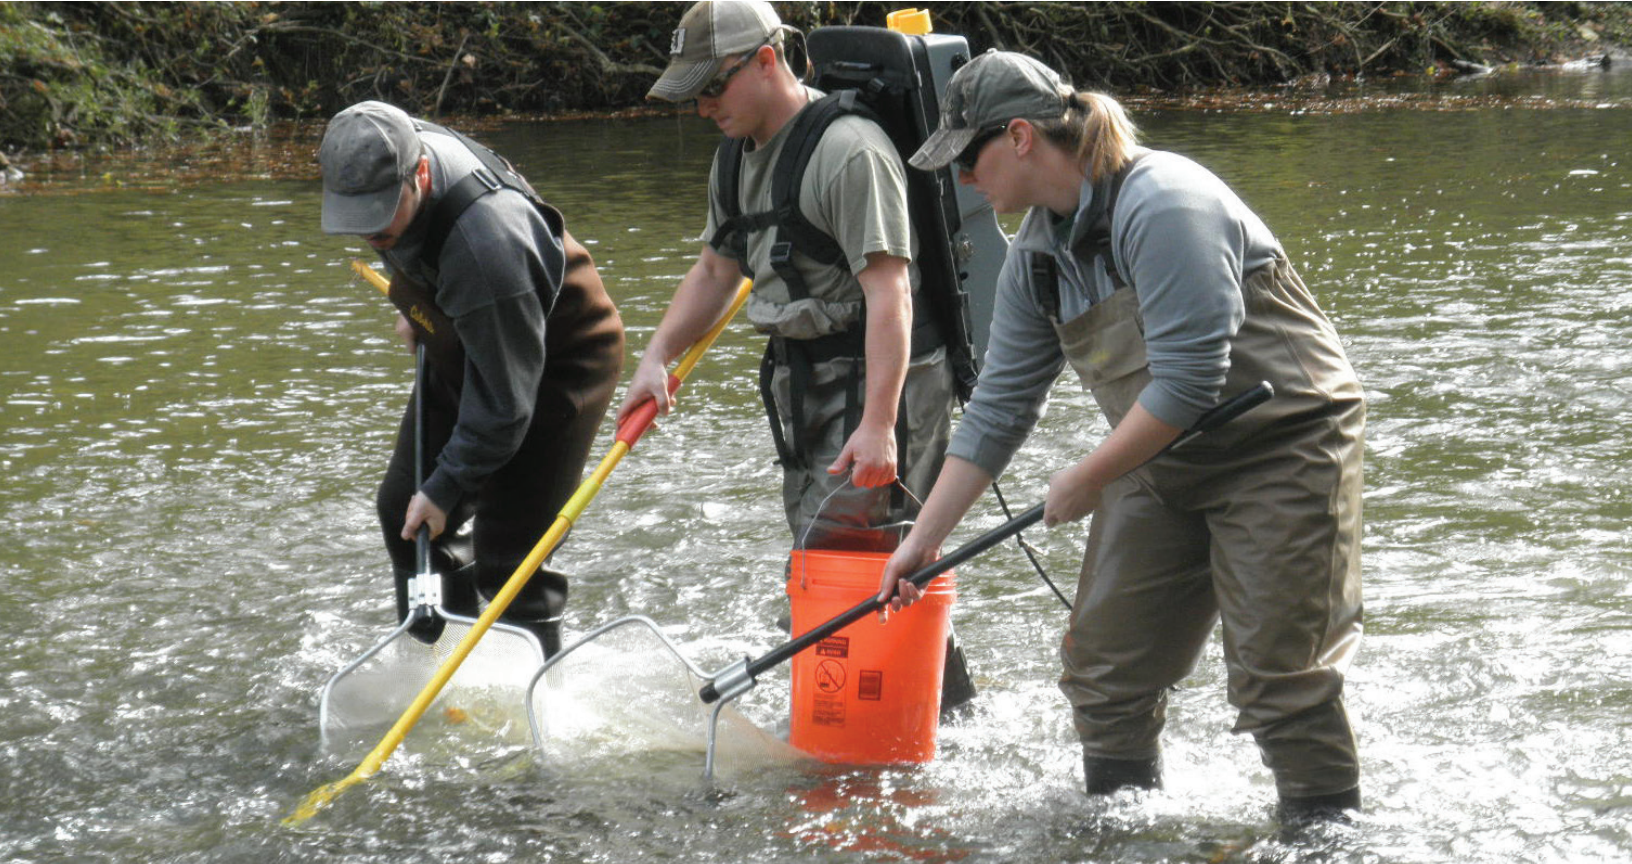
*Fish are collected using a common scientific survey method known as electro-fishing. Electricity is used to stun fish before they are caught. This method is used to sample fish populations and normally the fish are returned to the stream unharmed in as little as ten minutes after being stunned. One person operates the equipment that stuns the fish while others catch the stunned fish with a net and place them in a bucket of stream water. The fish are identified and then returned to the stream.*

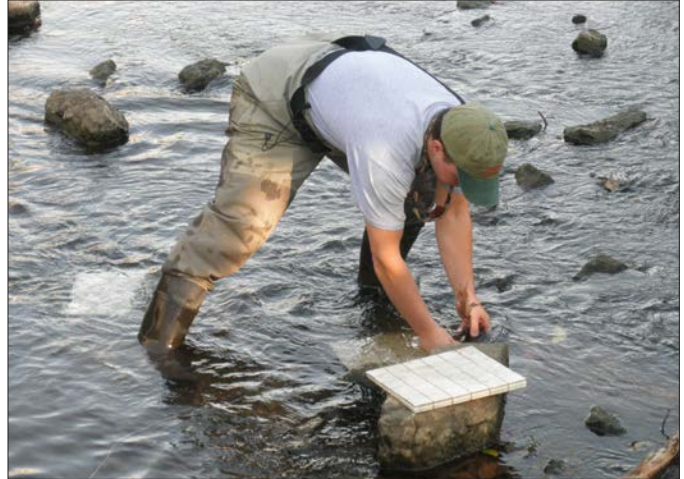
*Biologist placing ceramic tiles for collecting algae in the Middle Fork of Beargrass Creek*

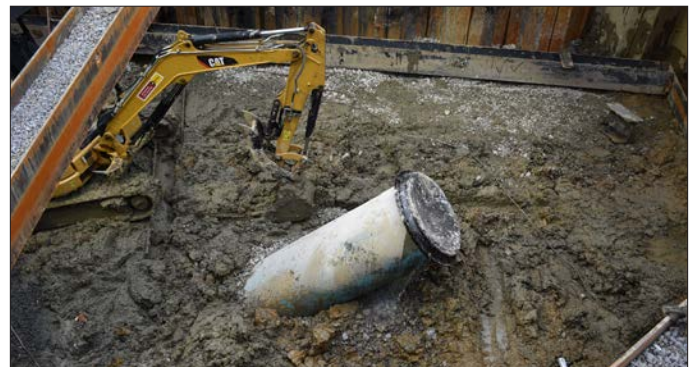
*Harrods Creek sewer repairs*

In 2019, MSD discovered a break in two sewer pipes along Harrods Creek. These breaks were causing sewage to run directly into Harrods Creek. MSD crews worked quickly to repair the breaks, but there were challenges due to the depth of the sewer and flooding from the Ohio River. Maintaining the sanitary sewer system is part of MSD's mission to provide safe, clean waterways. If you suspect a broken sanitary sewer, contact MSD's customer service at 502-540-6000.

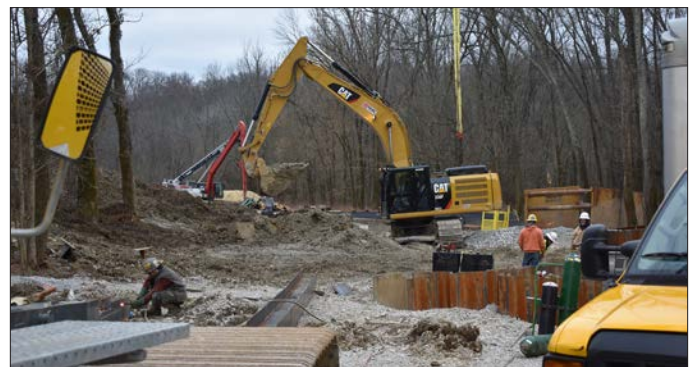
*Shaft to access break along Harrods Creek*

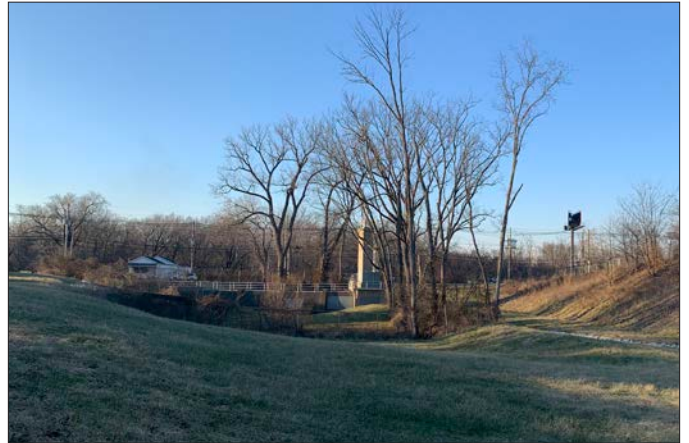
*Clifton Heights CSO Basin*

The Clifton Heights CSO basin, in the Muddy Fork watershed, was built into a grassy hillside next to the Mellwood Arts and Entertainment Center. The 7 million gallon basin captures and stores wastewater and stormwater during rain events and gradually releases it back into the sewer system when treatment capacity is available. This type of underground storage helps prevent wastewater from overflowing into Louisville's waterways.

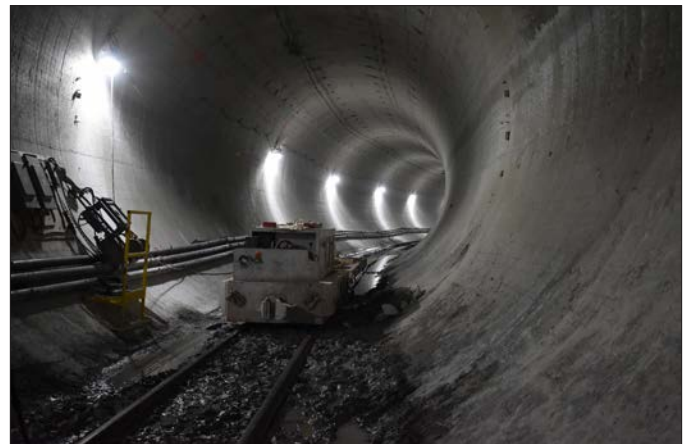
*Waterway Protection Tunnel*

On September 22, 2020, after 21 months of carving its way through four miles and 625,000 tons of rock 18 stories underground, the boring machine, “Bumblebee,” completed the path of the Waterway Protection Tunnel. The machine broke through the retrieval shaft wall at the intersection of Lexington Road and Grinstead Drive. Bumblebee was then disassembled and removed from the tunnel over the course of nearly two months.

Now the tunnel is being lined with 12-inch-thick concrete. The tunnel will capture and store up to 55 million gallons of combined stormwater and wastewater during rains, preventing the water from flowing untreated into the Ohio River and Beargrass Creek. The \$214 million project is part of MSD’s Consent Decree with the federal government to significantly reduce combined sewer overflows.

MSD's Waterway Protection Tunnel is an innovative way to store overflow of rainwater and wastewater underground until it can be pumped to a wastewater treatment facility, where it is cleaned and released to the Ohio River. The tunnel is a

\$201 million project now underway and planned to be operational in 2022. It is one part of MSD's \$1.15 billion Consent Decree to reduce sewer overflows. The tunnel is 4 miles long and 20 in diameter. It holds 55 million gallons, which is equivalent to 83 Olympic-size swimming pools.

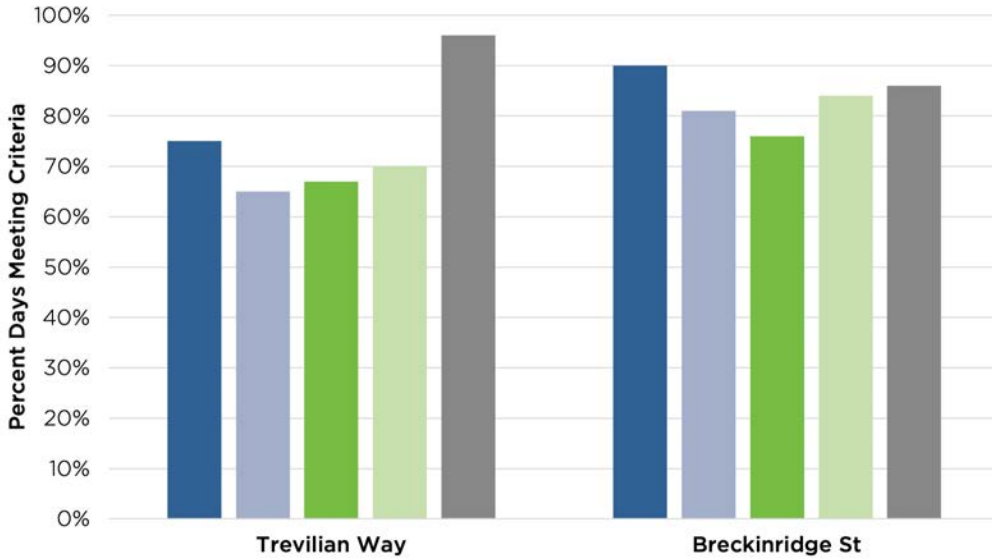
**Dissolved Oxygen in South Fork Watershed**  
Water Years (October 1 to September 30)

Since there is not a USGS gage at Brownsboro Road, no data is available for dissolved oxygen and temperature at that location. Dissolved oxygen conditions were “fair” at the South Fork sites from 2018-2020 and improving. Water temperature criteria were met 100 percent of the time.

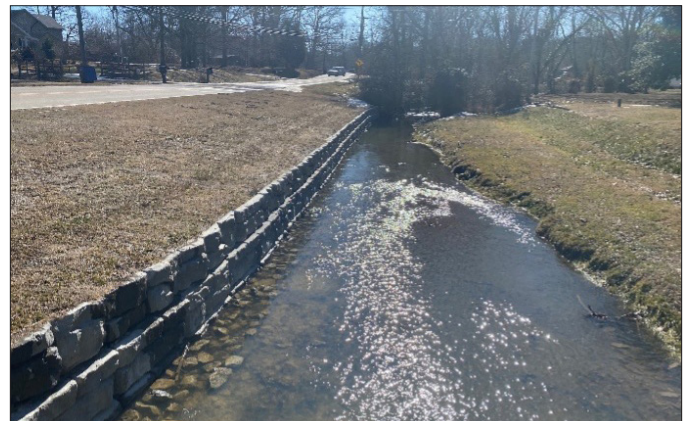
*Mount Holly bank stabilization*

As a part of MSD's Stormwater Quality Management Plan, stream restoration inspection and maintenance is a key component of ensuring and improving stormwater quality. The stabilization of the bank improves water quality through reducing erosion and increasing drainage efficiency. These improvements will help to decrease the amount of sediment that is picked up by stormwater and deposited into the creek.

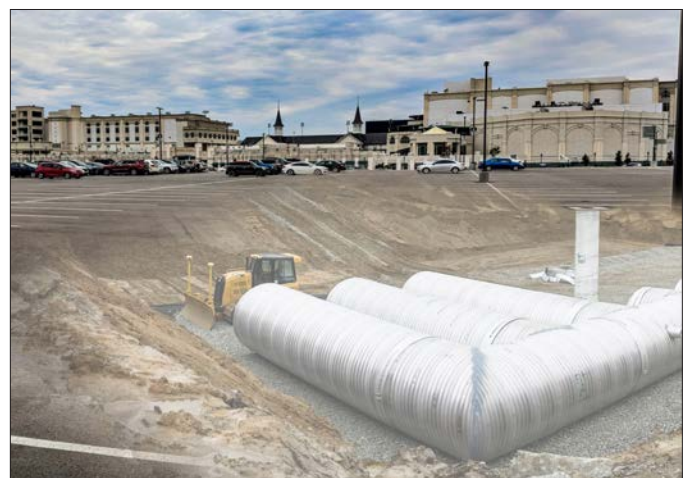
*Green Incentive Infiltration Basin at Churchill Downs*

Recent projects have included infiltration basins at the University of Louisville, Churchill Downs, and the Louisville Urban League Sports and Learning Campus and a sewer separation project at the Lynn Family Soccer Stadium. MSD has invested over \$42 million on green infrastructure projects that remove over 400,000 gallons of stormwater on an average annual basis.
